Diagnosis and Evaluation of Conservation State of Mural Paintings in Payathonzu Temple on Bagan Heritage Site in Myanmar

Journal of Conservation Science
2019;35(5):494-507

ABSTRACT A diagnostic investigation of the conservation state of damaged murals of the Payathonzu temple mainly indicated delamination, exfoliation, and contamination of the coloring layer; cracks and damage to the wall; and separation from gaps. In particular, vulnerabilities resulting from cracks in the wall and damage from gaps demand swift reinforcement measures. Ultrasonic testing uncovered damage caused by gaps between the base layer and plastered wall in several areas of the mural, vulnerable parts in the wall around the cracks, and considerable degradation of the physical properties where cracks and gaps were severe. Moisture measurements identified vast disparities in moisture depending on location even within a single area of the mural, and it was clear that these disparities were the result of environmental conditions such as humidity. Damage to the murals in monument 477 was the most severe, and a diagnostic of the physical properties uncovered severe physical damage to the upper part of the mural a

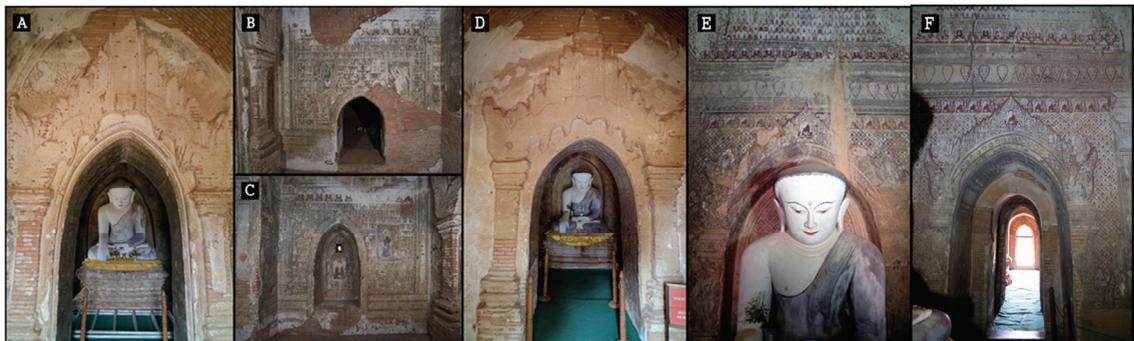
The mural paintings in Payathonzu temple were damaged by earthquake that hit the area in 1975. A dedicated team composed of government officials related to construction conducted repair of buildings and added mural paintings under the Yangon government. It was reported that the peeled off are near the mural painting was treated with cement used for construction, and the peeled off mural paintings and wall structures were filled and reinforced with brick powder, lime,

Figure 3. Image of status in Payathonzu temple. (A) #477 entrance hall to main hall, (B) #477 entrance hall-east side, (C) #477 entrance hall-west side, (D) #478 entrance hall to main hall, (E) #478 main hall-north side, (F) #478 main hall to #479 main hall.

The current Payathonzu mural paintings have suffered several damages like cracking, separation between layers, peeling off and exfoliation. In the past, repair of mural paintings was conducted several times, but the repairs led to cracks in the area or separation from wall structure. In some cases, the fixing agents used in the past made the painting too shiny or led to fading or peeling off together with the painting layer.

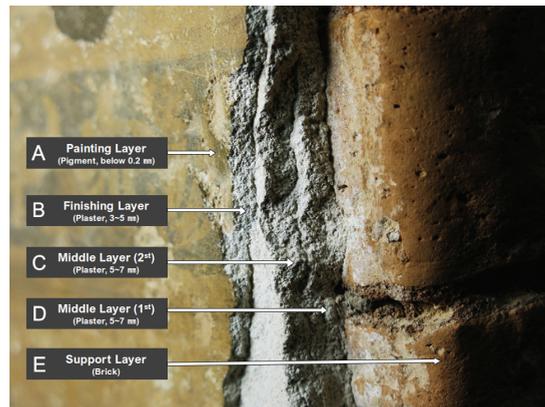
of about 3–5 mm, though also varying with locations. As for the painting layer, it is found that overall it was painted considerably thin, though varying with pigments used. The thickness of the painting layer varies depending on the pigment layer used, but it is generally found to be colored on a thin layer (Figures 5 and 6).

Figure 6. The structure of mural painting in Payathonzu temple. (A) Painting layer over the finishing layer (below 0.2 mm), (B) Finishing layer of thin lime plaster (3–5 mm), (C) Second middle layer (3–5 mm), (D) First middle layer (5–7 mm), (E) Support layer made of piled bricks.

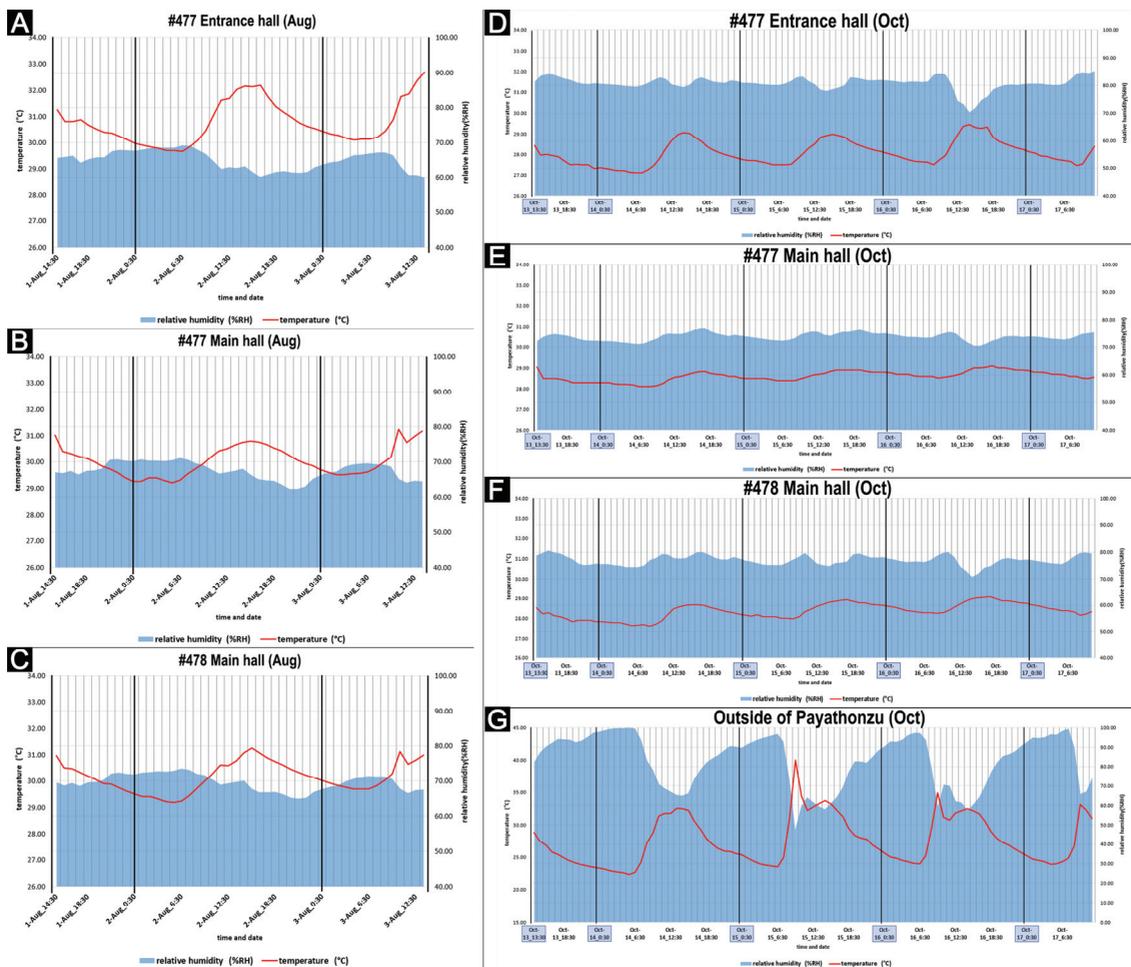
and the lowest temperature was 3.0°C . The relative humidity was average 64.9%, and it was found that difference between the highest humidity and the lowest humidity was 9.2%. In October, it was found that the average temperature was 28.1°C , and the difference between the highest temperature and the lowest temperature was 2.4°C . The relative humidity was average 80.8%, and difference between the highest humidity and the lowest humidity was 15.0% (Table 2 and Figure 7).

To sum up the results, it is judged that entrance hall of #477 is considerably affected by external environment. To compare it with other measurement areas, it was found that its differences between the highest and lowest temperature and humidity were greatest. According to the results of measurement in August, the relative humidity rises during hours from evening to early morning when temperature drops, but is low during daytime, showing the opposite aspect. However, in October that is the latter half of rainy season, the relative humidity is lowest 70.2% and highest 85.2%, maintaining the humid condition of average 80.8% all day long. From this, it can be seen that more humid environment is maintained in August, early rainy season, than in October, the latter half of rainy season. The moisture contents of the murals also showed noticeably wide variations according to locations, and it was found that loss and damage were severe in the surfaces of murals on which pictures were painted.

Figure 7. Temperature and humidity results of Payathonzu temple. (A) Aug. #477 entrance hall, (B) Aug. #477 main hall, (C) Aug. #478 main hall, (D) Oct. #477 entrance hall, (E) Oct. #477 main hall, (F) Oct. #478 main hall, (G) Oct. Outside of Payathonzu.

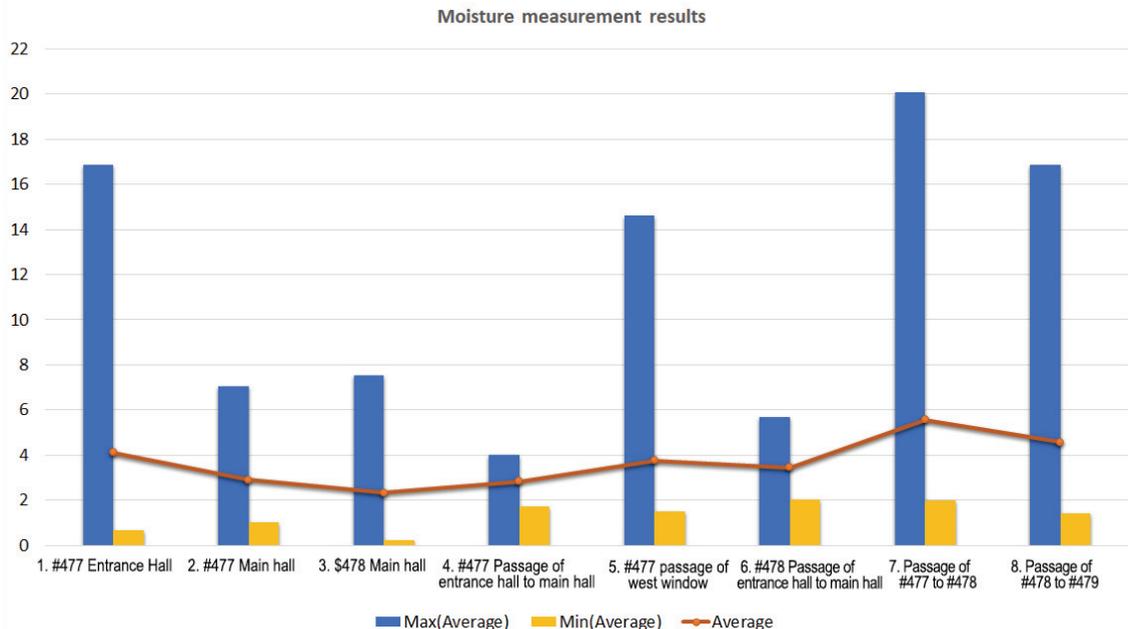
Figure 8. Moisture measurement results.

passage from #477 main hall to #478 main hall were high. The average, minimum and maximum values were relatively high for the passage from #478 main hall to #479 main hall. The passage from hall to hall showed high moisture levels while the wall located behind the main hall showed relatively low moisture level(Figure 8).

Compared to the #477 main hall and entrance hall exhibited a significantly higher moisture ratio and a significant variation in the ratio. The external environment is causing significant changes in humidity. In particular, the degree of damage tends to be severe in areas where the moisture ratio showed large variation.

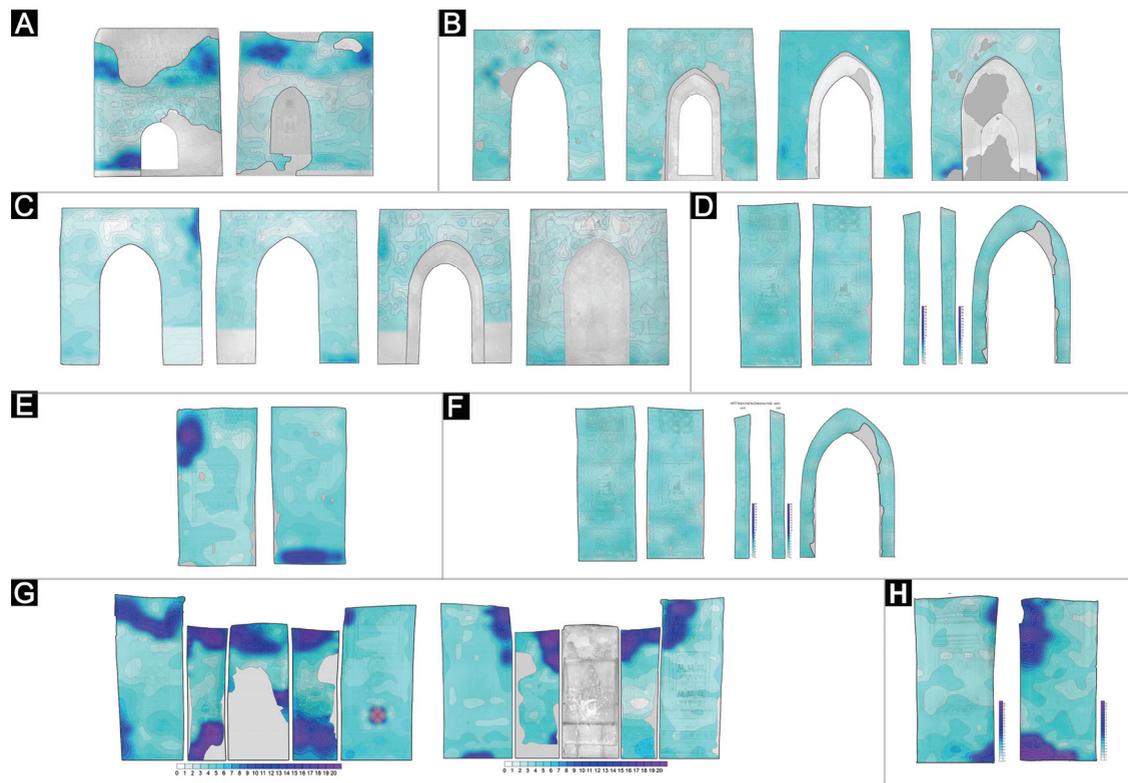
Figure 9. Image mapping of moisture measurement. (a) #477 entrance hall east and west, (b) #477 main hall, east, west, south, north, (c) #478 main hall, east, west, south, north, (d) #477 passage of entrance to main hall, east 1, west 1, east 2, west 2, arch, (e) #477 passage of west window, north, south, (f) #478 passage of entrance to main hall, East 1, west 1, east 2, west 1, arch, (g) passage of #478 to #479, north, south, (h) passage of #477 to #478, north 1 • 2 • 3 • 4 • 5, south 1 • 2 • 3 • 4.

The moisture ratio was high in the passage, which is a relatively small area compared to the main hall, and the ratio was somewhat higher in the #478 main hall than in the #477 main hall. Such tendency may be connected to the humidity measured inside the temple(Figure 9).

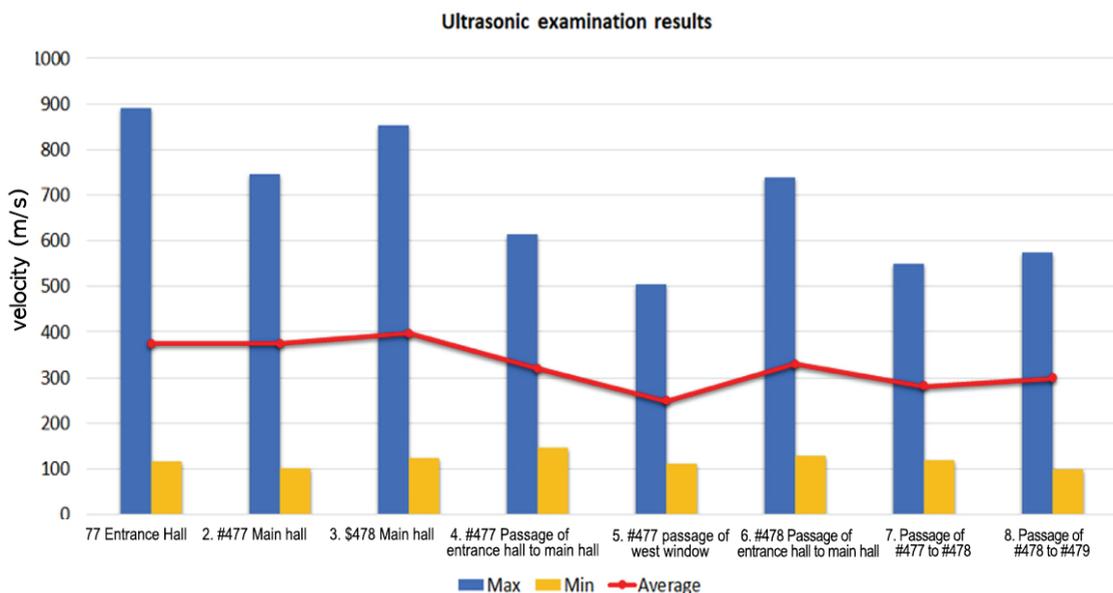
Figure 10. Ultrasonic examination results.

The distribution of ultrasound speed was mapped for areas where the properties are not in good quality due to crack, damage or peeled off wall structure. Based on the results of all measurements, the maximum ultrasound speed was measured to be 891 m/s, and the minimum ultrasound speed was measured to be 105 m/s(Table 4, Figure 10).

Overall, high ultrasonic speed was detected at the main hall of #478, and the entrance hall(west) of #477 showed the

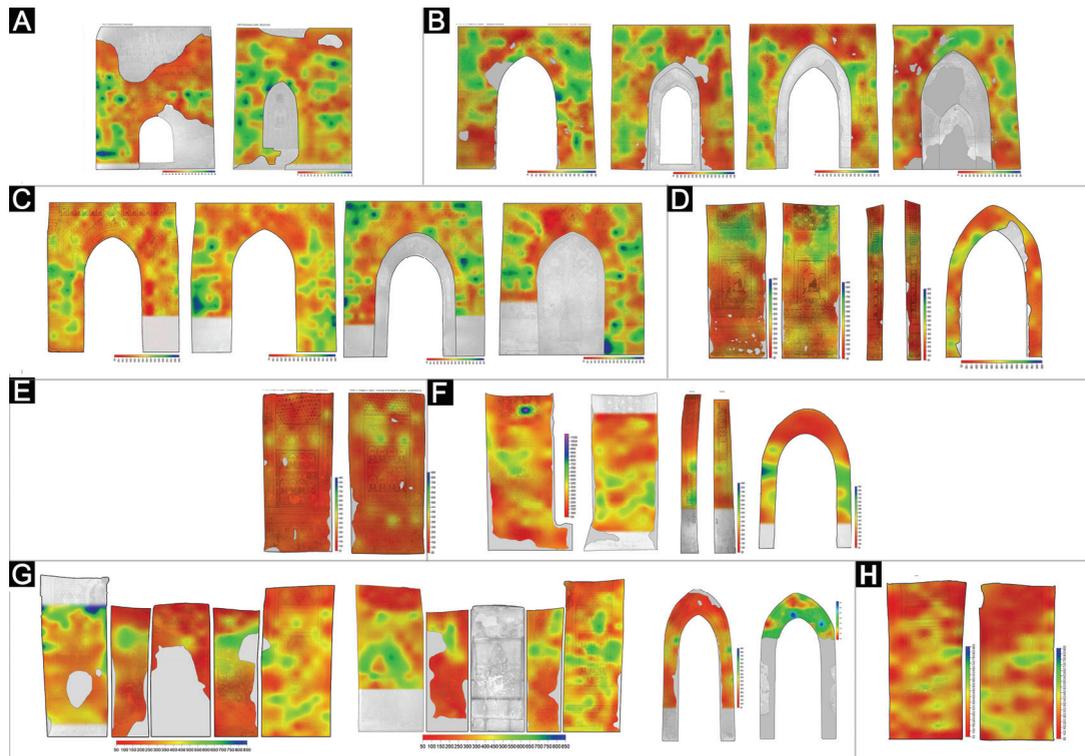
Figure 11. Image mapping of ultrasonic test. (a) #477 entrance hall east and west, (b) #477 main hall, east, west, south, north, (c) #478 main hall, east, west, south, north, (d) #477 passage of entrance to main hall, east 1, west 1, east 2, west 2, arch, (e) #477 passage of west window, north, south, (f) #478 passage of entrance to main hall, east 1, west 1, east 2, west 1, arch, (g) Passage of #478 to #479, north, south, (h) Passage of #477 to #478, north 1 · 2 · 3 · 4 · 5, south 1 · 2 · 3 · 4, arch 1, arch 2.

Therefore, ultrasonic inspection of the mural may provide objective data on the areas that require preservation treatment, such as cracks and lifting of the wall. In particular, the results of the inspection may be used as reference data when it comes to reinforcing vulnerable areas of the wall, such as the upper part of the wall or vault of the passage (Figure 11).

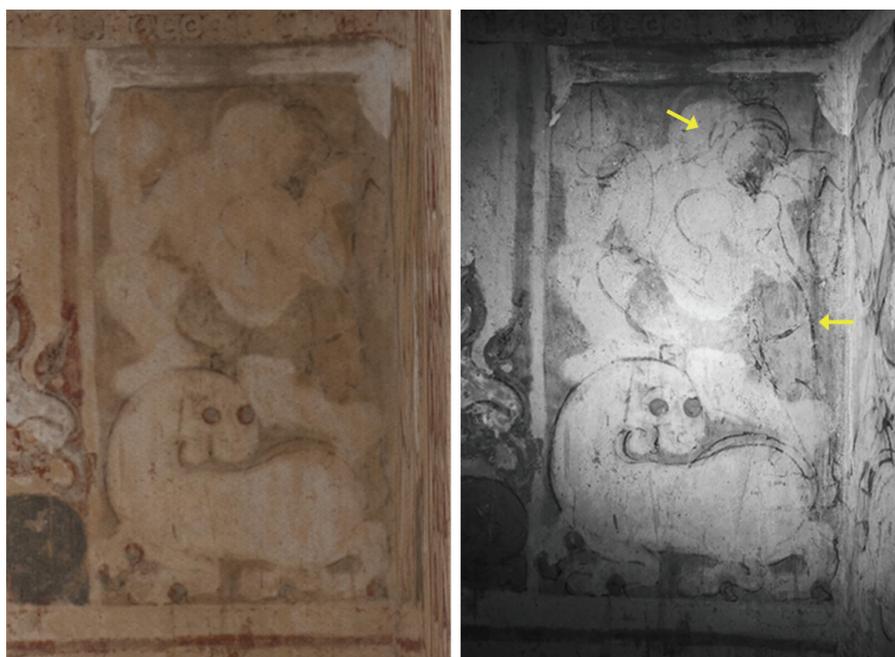
in parts of the areas. In particular, a clearer visual of images from the painting layer that have been contaminated were obtained. Also, an infrared response was used to identify the underlining that was not visible to the naked eye in the form of the edge figure on the south side of #478 main hall (Figure 12).

Figure 12. Images of the visible light(left) and the infrared light(right) and underpainting detected(#478 main hall-south side).

If cleaning is carried out, the image identified through infrared irradiation can be referred to as useful data, allowing the mural to be restored more clearly. Also, damaged areas in the painting layer and the damage caused by synthetic resins, as identified through the ultraviolet inspection, can serve as useful information in the conservation process, such

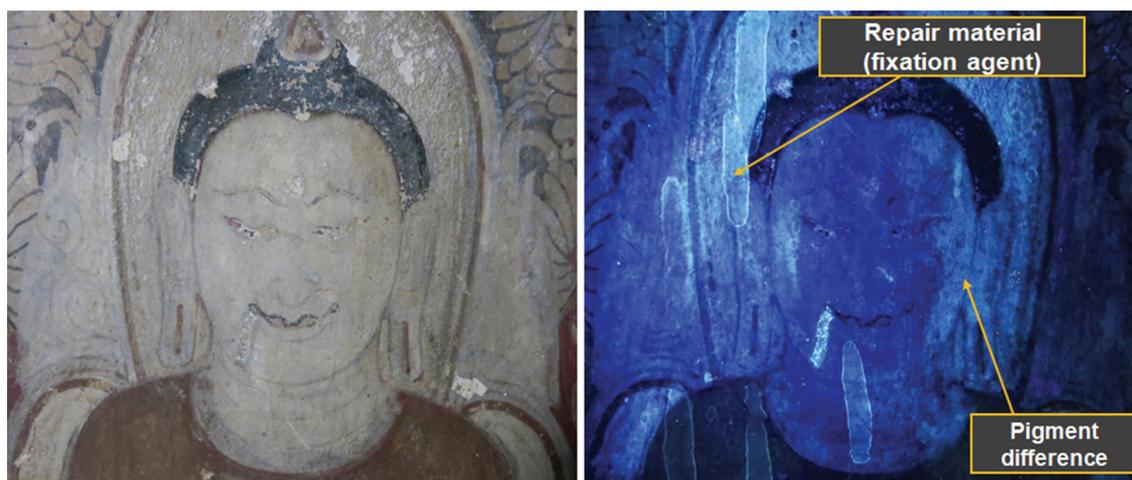
The ultraviolet inspection confirmed various information that was unavailable under the visible rays. Through the fluorescence reaction, areas that had been painted over as well as areas damaged from discoloration were clearly identified. In particular, traces of repair materials—presumed to be PVAc—and excess application of such materials also were revealed. In addition, areas of similar colorations were clearly identified (Figure 13).

Figure 13. Images of the visible light(left) and the ultraviolet light(right)(#477 main hall-south side).

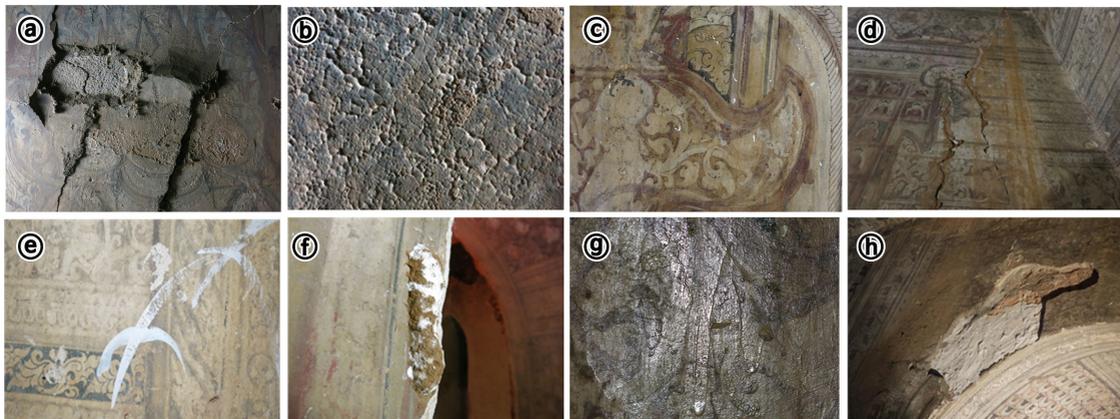
Eight types of damage types, viz. crack, delamination and exfoliation of the painting layer, uplift of the finishing layer, contamination, biological damage, water leak and artificial damage were assessed. Cracks were classified into fine cracks

and cracks in the wall; damage in the colored layers was classified into delamination, exfoliation and discoloration; and contamination was classified into dust and soot, and presence of previous restoration materials(Figures 14 and 15).

The #477 entrance hall, #477 main hall, and #478 entrance hall all displayed marked damage and contamination to the painting layer. All three areas showed severe damage, in the order of exfoliation of the finishing layer, cracks on the wall, and presence of previous restoration materials. Broken down

Figure 14. Types of damages in mural paintings in Payathonzu. (a) Crack, (b) Damages of painting layer, (c) Contamination, (d) Water leak, (e) Artificial damage, (f) Biological damage, (g) Previous repair material, (h) Exfoliation of finish layer.

Through the assessment of the conservation status of the mural, it was possible to objectively suggest that the painting layer and the wall require conservation treatment. In particular, through the inspection of physical properties on the surface and the damage map, it has been determined that the level of structural damage has aggravated and it is suggested that reinforcing work on the lifting and cracks is carried out on an urgent basis.

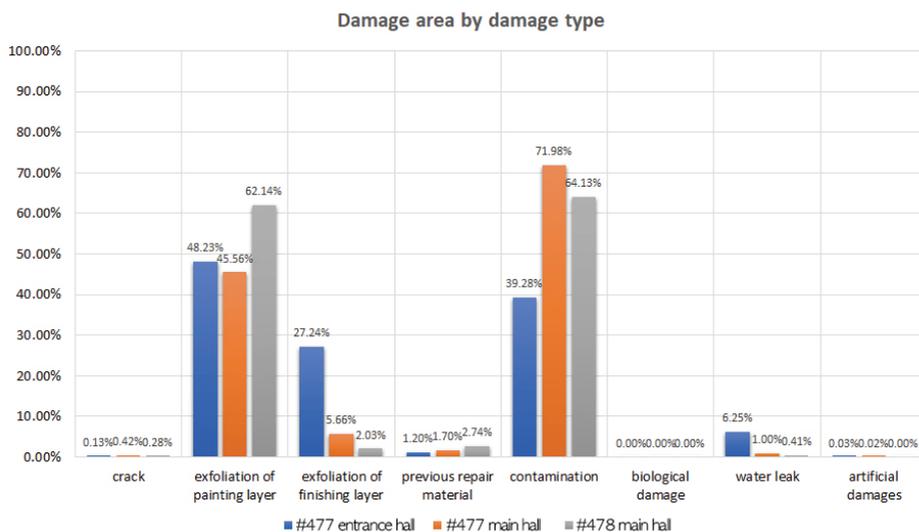
Figure 15. Damage rate by damage type.

When the status of damage is assessed comprehensively, the #477 entrance hall showed a relatively high level of damage overall, while the #478 entrance hall showed the least damage. As for the type of damage, all three areas showed the highest level of damage in the painting layer caused by peeling off, exfoliation, and contamination of the layer, followed by exfoliation of the finishing layer, and cracks on the wall. However, such results were determined based on information gathered in the process of optical survey of the surface of the mural. Thus, the following facts are to be
