Clarification the Current Situation of Deterioration and Its Causes of Modernization Heritage Built with Bricks in Japan: A Case Study of Long-Term Monitoring Investigation at Sarushima Battery, Yokosuka, Japan

Journal of Conservation Science
2022;38(4):265-276

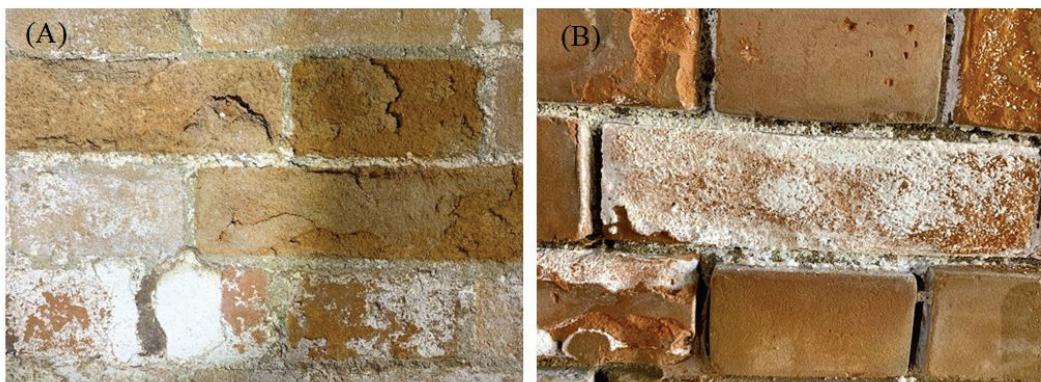
Figure 1. (A) Brick surface with peeling, and (B) Bricks with salt weathering.

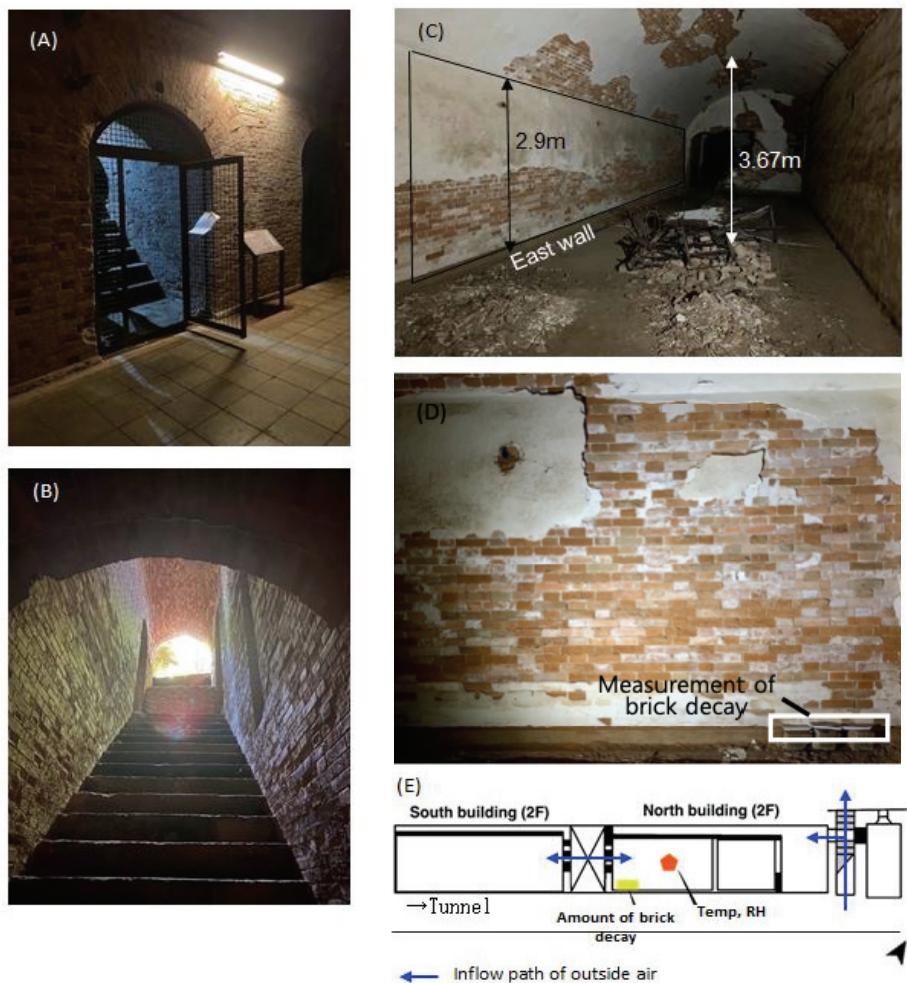
considered to have been constructed to prevent moisture from entering the ammunition depot and to discharge moisture from the inside to the outside. In fl-2, a large collapse of the south wall was observed, and the deterioration of the brick surface on the east wall was observed (Yokosuka City, 2014). The area of fl-2 where the survey was conducted is currently closed to the public. Therefore, people do not enter this area except researchers.

Figure 6. (A) The entrance of fl-2 from tunnel, (B) The window near the entrance of fl-2, (C) inside of fl-2, (D) The east wall in fl-2, and (E) 2D diagram of inside fl-2. (Created by the author.)

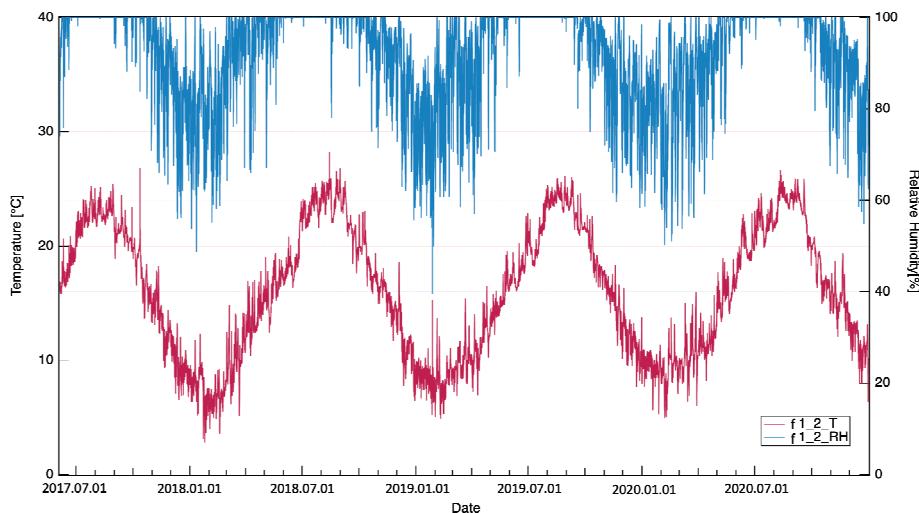
The temperature and RH results measured inside f1-2 and outdoors from 2017.06. ~ 2020.12 were shown in Table 1. Moreover, the temperature and RH behavior inside f1-2 was shown in Figure 8. As a result of the monitoring investigation, the temperature and RH inside the brick structure have not changed significantly over the past three years, and that the same temperature and RH behavior was maintained every year. The temperature inside the structure is 1°C to 2°C lower than outdoors, and the range of fluctuation is slightly smaller. However, the RH is higher than that of the outdoors, and the RH reached 100% from June to August, when both temperature and RH were at their highest. Thus, the environment inside f1-2 was found to be high humidity environment.

**Figure 8.** Behavior of the temperature and RH in f1-2.

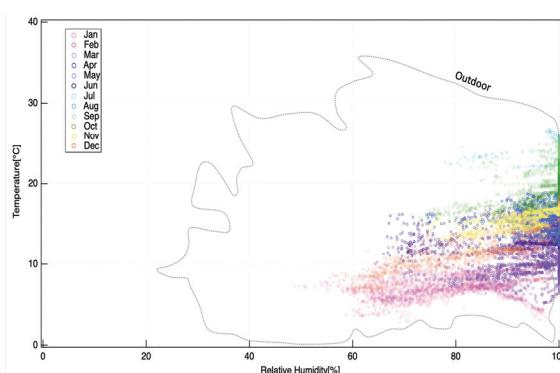
generally lower, and the RH is higher than that of the outdoors. The temperature and RH are lowest in the winter months of January and February and gradually increase after March which is the spring season in Japan. The RH reaches 100% during the rainy season from June to July and remains high humidity until September, followed by a gradual decrease in both temperature and RH until December. Additionally, this behavior was linked to the outdoor temperature and RH behavior. These results indicated that the temperature and RH in f1-2 changed in tandem with the outdoor temperature and RH behavior, but the environment became slightly cooler and more humid than outdoors. As mentioned earlier, since there is a window near the entrance of f1-2 for outside air to enter f1-2, the temperature and RH behavior in f1-2 seems to be affected by the outside air.

Figure 9. Behavior of the temperature and RH for each month in f1-2.

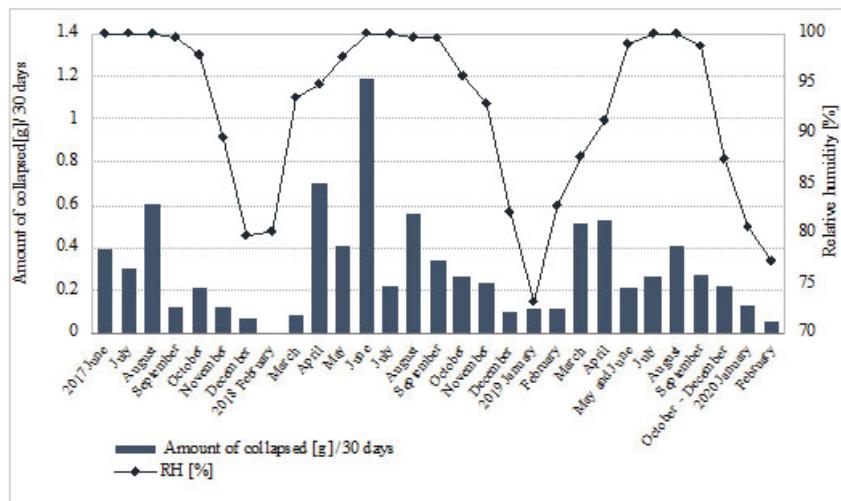
Deterioration of the bricks in f1-2 based on the environment inside f1-2 and the moisture absorption and desorption characteristics of the Toyo-gumi bricks was discussed. The behavior of the amount of brick decay from the brick wall and RH in f1-2 were shown in Figure 10. The amount of brick decay in f1-2 was found to increase in April, which corresponds to the spring season in Japan, and from June to August, which corresponds to the rainy season to the summer season. In particular, the rapid increase of the amount of brick decay in June 2018, was attributed to the presence of detached brick decay approximately 1.5 cm in diameter in addition to bricks that had collapsed in powdery form within the collapsed bricks. Moreover, the period when the amount of brick decay increased matched with the period when RH in f1-2 increased. However, the tray installation method needs to be improved because when the trays were checked during the survey in July 2018, we found that the trays had tipped over and were not accurately measured. On the other hand, the amount of brick decay tended to decrease from August onward and during the winter season, and few brick decay were observed from the brick walls, especially in January and February of each year. Furthermore, the period of the decrease in the amount of brick decay matched with the period of the decrease in RH. According to the results of an investigation which was conducted in 2002 by Oguchi at the kiln of the Shimotsuke Brick Production Company, Gunma, Japan, the weight of brick decay was

Figure 11. Behavior of the amount of brick decay and RH in fl-2.

reported to increase during period from early spring to late summer, when brick decay is triggered at the periods of increased RH and tidal dissolution of existing salts in the bricks (Oguchi *et al.*, 2002). It has been pointed out that this is because the salts on the surface have absorbed the moisture in the air and become heavier, which adsorbs the brick parts at the time they collapse from the surface and encourages them to collapse together (Kuchitsu, 2005). When considered in conjunction with the moisture absorption and desorption characteristics of Toyo-gumi bricks, the period from March to April, when the amount of brick decay increased the most, matches with the period when the bricks were in the moisture absorption process and the RH in fl-2 reached over 90%. The correlation coefficient between RH and the amount of brick decay was calculated and found to be positive at 0.5. For these reasons, a relationship was found between the increase in RH in the structure and the collapse of the brick surface.
