Diagnosis and Evaluation of Conservation State of Mural Paintings in Payathonzu Temple on Bagan Heritage Site in Myanmar

Journal of Conservation Science
2019;35(5):494-507

ABSTRACT A diagnostic investigation of the conservation state of damaged murals of the Payathonzu temple mainly indicated delamination, exfoliation, and contamination of the coloring layer; cracks and damage to the wall; and separation from gaps. In particular, vulnerabilities resulting from cracks in the wall and damage from gaps demand swift reinforcement measures. Ultrasonic testing uncovered damage caused by gaps between the base layer and plastered wall in several areas of the mural, vulnerable parts in the wall around the cracks, and considerable degradation of the physical properties where cracks and gaps were severe. Moisture measurements identified vast disparities in moisture depending on location even within a single area of the mural, and it was clear that these disparities were the result of environmental conditions such as humidity. Damage to the murals in monument 477 was the most severe, and a diagnostic of the physical properties uncovered severe physical damage to the upper part of the mural a

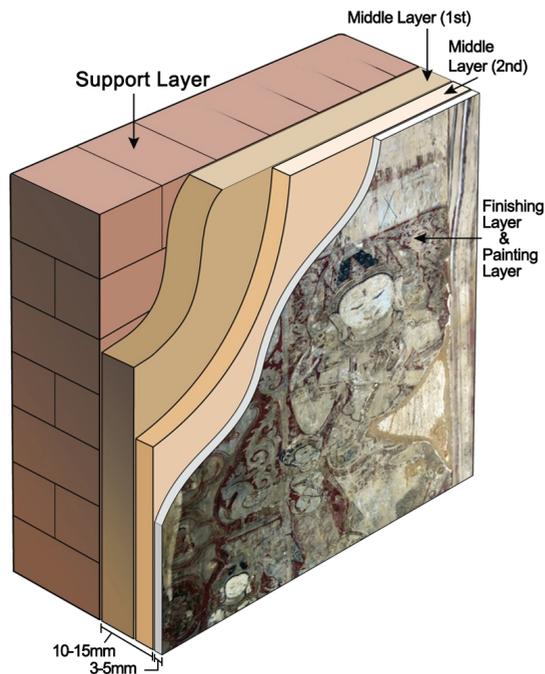
Figure 5. Diagram of structure and layers of mural painting of Payathonzu temple.

It has been confirmed that the structure of the mural is composed of a wall made of piled bricks with several layers of lime plaster on top, and the painting over the top.

The middle wall, which forms the ground layer, shows the thickness of average 15–20 mm, albeit slightly varying with its locations. Although it is found that it consists of 2–3 layers, it was plastered more times than them, and rather thick layers are occasionally found, too. As for the finishing layer, it is found that similar conditions of kneading to the middle layer were used, and the layer has the thin thickness

of about 3–5 mm, though also varying with locations. As for the painting layer, it is found that overall it was painted considerably thin, though varying with pigments used. The thickness of the painting layer varies depending on the pigment layer used, but it is generally found to be colored on a thin layer (Figures 5 and 6).
