Clarification the Current Situation of Deterioration and Its Causes of Modernization Heritage Built with Bricks in Japan: A Case Study of Long-Term Monitoring Investigation at Sarushima Battery, Yokosuka, Japan

Journal of Conservation Science
2022;38(4):265-276

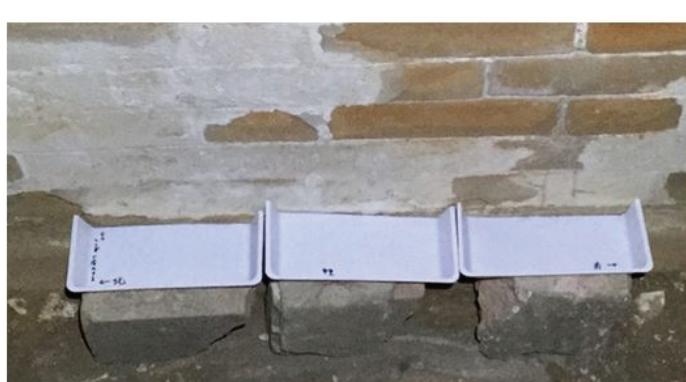
Figure 7. Measuring the amount of brick decay.

The amount of brick decay from the brick wall was measured by placing three trays, each with a bottom area of 140 cm² in contact with the brick wall (Figure 7). The trays were made of polypropylene, cut to a width of 20 cm and a depth of 7 cm (Dispo-tray manufactured by As One corporation). These trays were placed near the right edge of the east wall (Figure 6D.) The measurement was conducted from 2017.06. ~ 2020.03. The brick decay was collected once every month or every two months and weighed. The amount of brick decay was converted to the amount of it per 30 days in each measurement period because of the variation in the measurement period in the month of the investigation.

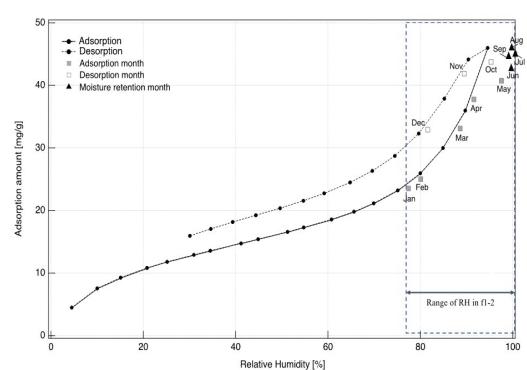
Figure 10. Water adsorption/desorption isotherm of Toyo-gumi brick.

brick under the environment in f1-2 was discussed. Figure 10 shows the result of water adsorption/desorption test of Toyo-gumi bricks conducted under 25°C conditions with the cooperation of Environmental System Research Laboratory, Hokkaido University, Japan. In the case of Toyo-gumi bricks, it was found that when the RH exceeded 80%, moisture absorption proceeded, and the amount of moisture contained in the bricks increased. The moisture was then released with the RH decreases. During the moisture release process, little moisture was released from the brick until the RH reached 90%, but moisture was released when the RH fell below 90%. Considering this characteristic together with the temperature and RH environment in f1-2, it is considered that the bricks are in the process of absorbing moisture from February to June, when the RH begins to increase to 75% or more and then, from June to September, when the RH in f1-2 reaches 100%, the bricks retain the moisture they have
